Manhole Inspection Summary

Manhole # S11S__008MH

Insp Date: **4/4/08 11:00 AM**

Location Address: **810 S. Caton Ave**

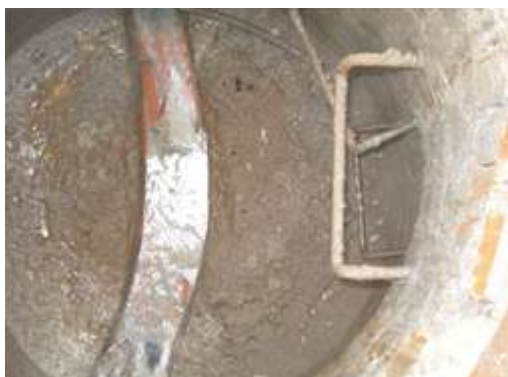
Defect 6

Condition: ☐ Sound ☐ Cracked ☐ Root Intrusion ☐ Deteriorated ☐ Leaks ☒ **Debris**

bench & channel debris

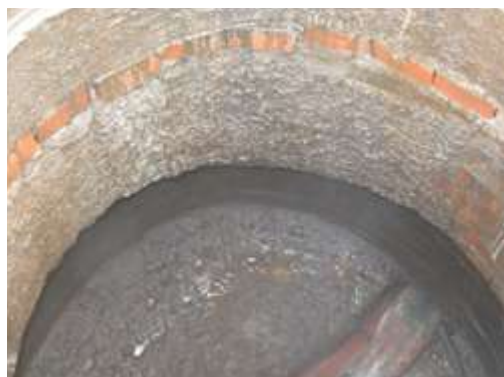
Defect 5

Infiltration: ☐ None ☐ Joint ☐ Cracks ☐ Mortar ☐ Roots ☒ **Wall**

Chimney Infiltration

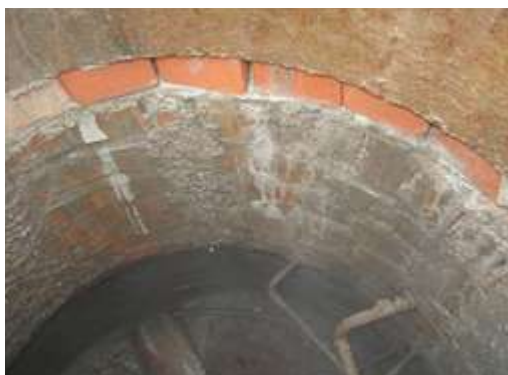
Defect 1

Condition: ☐ Sound ☐ Cracked ☐ Root Intrusion ☒ **Loose Brick** ☐ Deteriorated

Loose bricks and infiltration from top and under frame/infiltration evidence at corbel and chimney

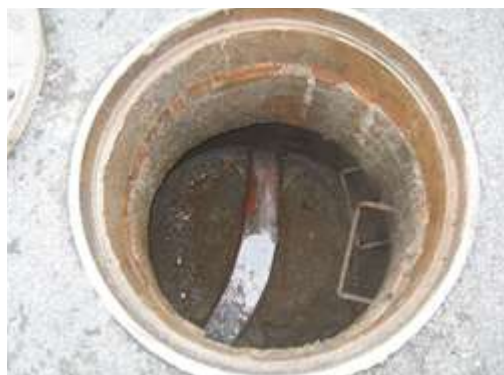
Defect 2

Frame Offset: **1** (in.) Condition: ☐ Sound ☐ Cracked ☒ **Leaks**

frame leaks

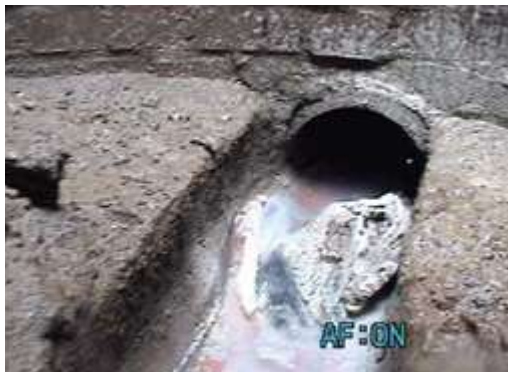
Defect 4

Debris in channel

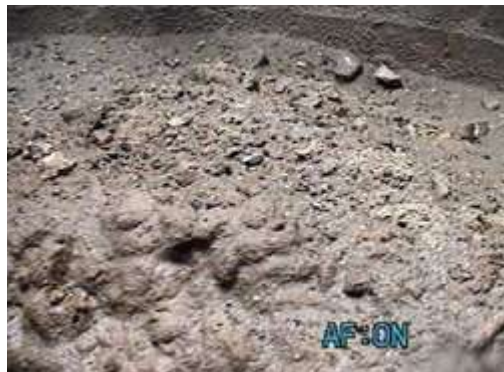
Defect 3

Debris on bench

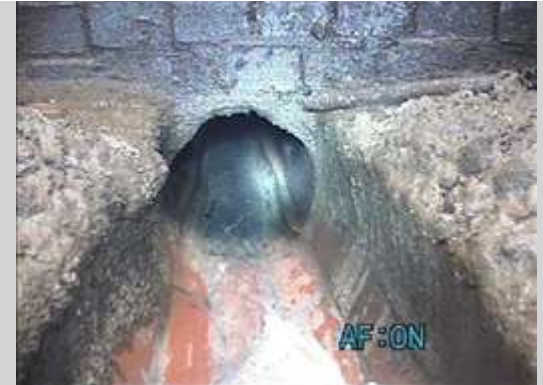
12 O'Clock Outflow

Pipe Height: **8.4** (in.) Rod and Bar (Angled)
Pipe Material: **Clay** ☐ Pipe Lined
Invert Depth: **6.40** (ft.) Flow Characteristics: **Slow**
Deposits: ☒ None ☐ Mud ☐ Sludge ☐ Debris ☐ Grease
Silt Depth: **0** (in.) Deposits Extent:
Infiltration: **None** Pipe Seal Cond: **Sound**

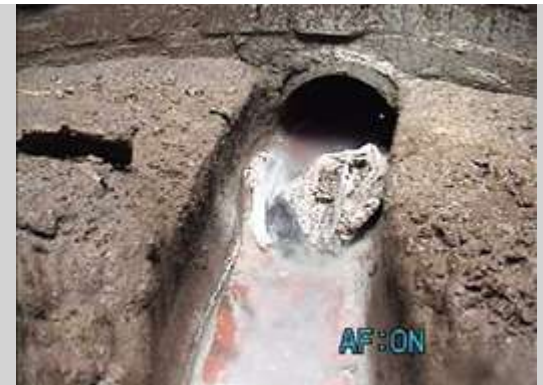
7 O'Clock Inflow

Pipe Height: **7.2** (in.) Rod and Bar (Angled)
Pipe Material: **Clay** ☐ Pipe Lined
Invert Depth: **6.20** (ft.) Flow Characteristics: **Slow**
Deposits: ☒ None ☐ Mud ☐ Sludge ☐ Debris ☐ Grease
Silt Depth: **0** (in.) Deposits Extent:
Infiltration: **None** Pipe Seal Cond: **Sound**
